METALS HANDBOOK

VOL. 9
FRACTOGRAPHY AND ATLAS OF FRACTOGRAPHY

8th EDITION

Fractography and Atlas of Fractographs

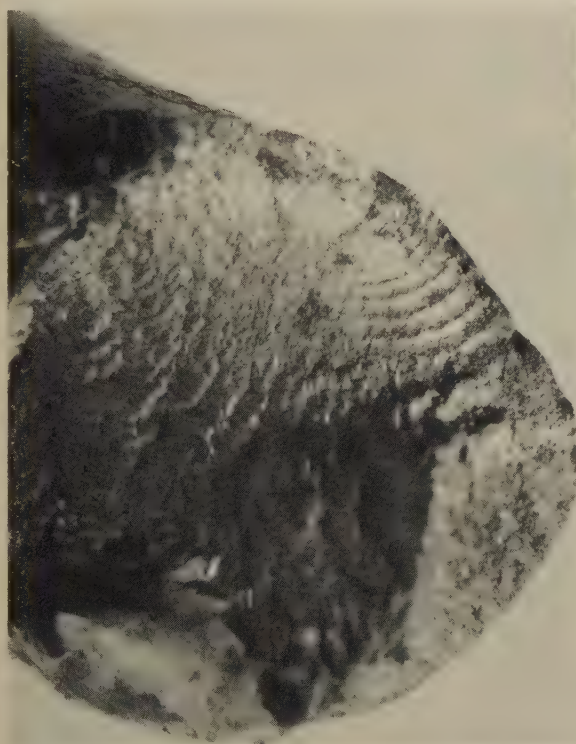
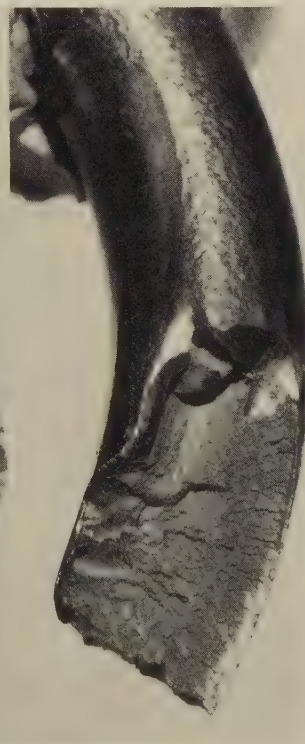
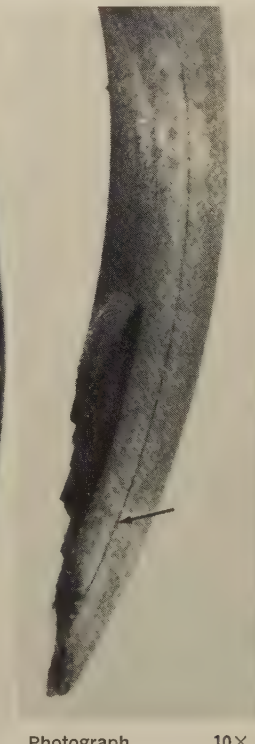
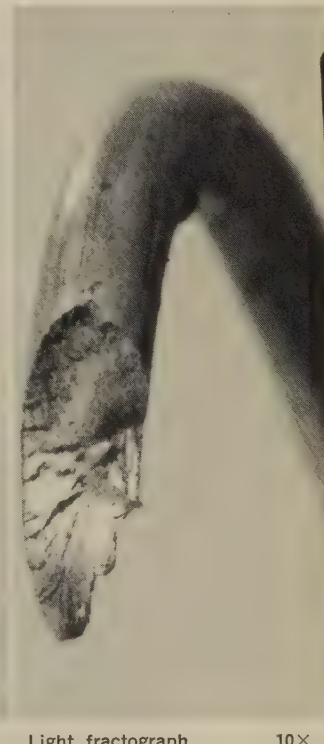
Light fractograph
4910 Fracture surface at right in 4909, shown at higher magnification. The nucleus of the fatigue crack is clearly visible on the wire surface at top, with a succession of beach marks fanning out below it. The surface of the zone of final, fast fracture appears to be quite woody.

Light fractograph
4911 Surface of a complex fatigue fracture in a valve spring formed from 1070 steel wire, showing two facets at right angles.

Photograph
4912, 4913 Fatigue fracture in a spring of 1070 steel wire with a hardness of Rockwell C 54. At left (4912) is a side view of one fracture surface, deep etched to show a long seam (at arrow). At right (4913) is a frontal view of the mating fracture surface, showing the fatigue-crack origin (at right), which is at a second seam.

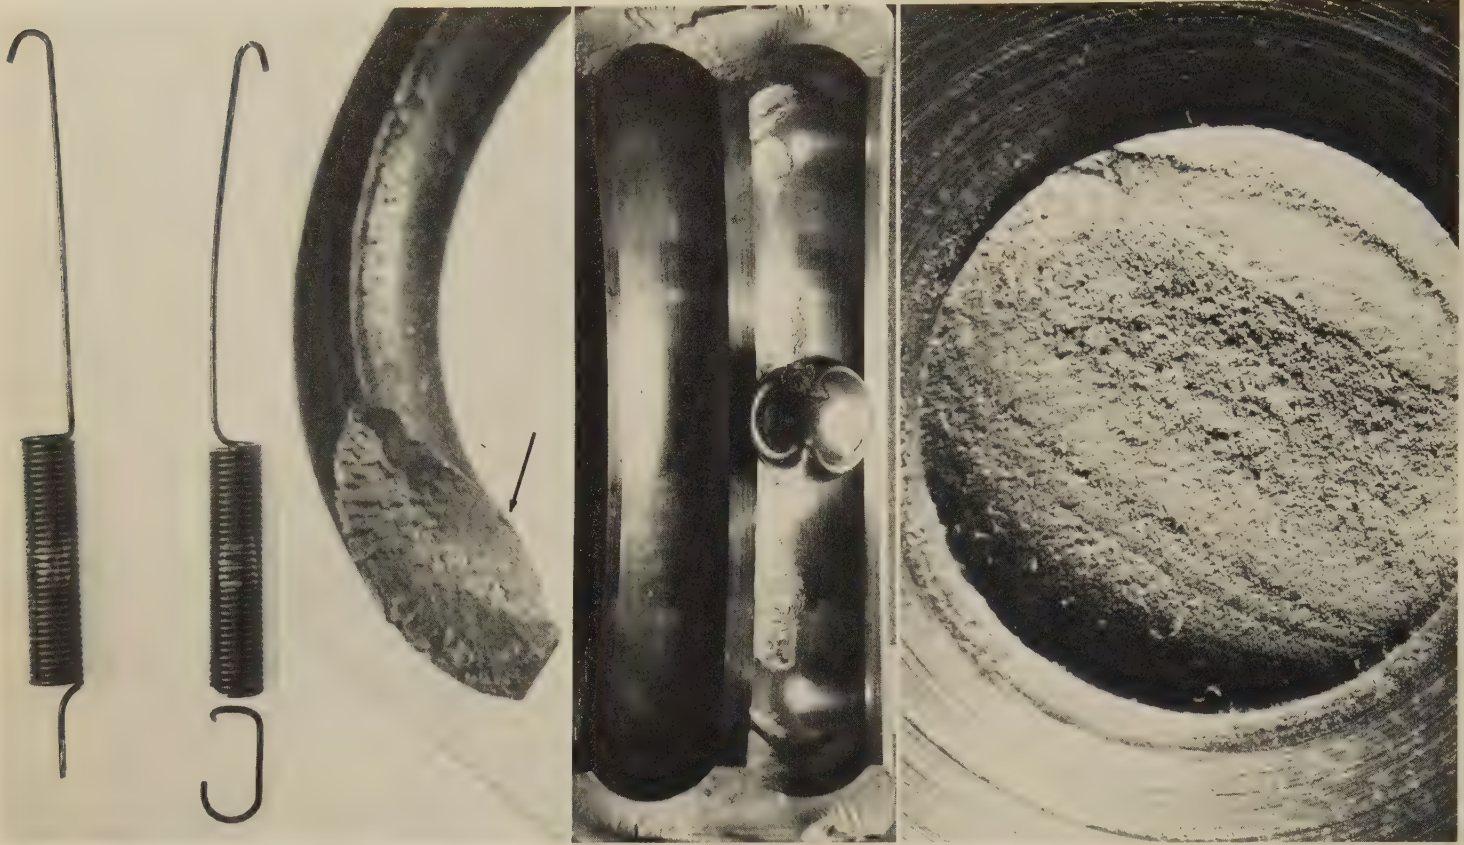
Photograph $\frac{3}{4} \times$ Light fractograph $15 \times$
4914, 4915 At left (4914) are two fatigue-fractured springs of 0.050-in.-diam cold drawn 1070 steel music wire. Coil diameter was about $\frac{3}{8}$ in. At right (4915) is a fracture surface of one of the springs in 4914, showing a fatigue-crack origin at right edge (arrow).

Photograph $0.95 \times$
4916 Fracture in the outer race of a high-carbon steel bearing of a forced-lubrication pump. Flaking of the ball bearing suggests overloading.

Light fractograph $2.1 \times$
4917 Surface of a fatigue fracture in a high-carbon steel spindle of an air-pump valve. Fatigue beach marks are clearly visible. The coarse machining marks on the surrounding shoulder indicate that machining produced notches that were deep enough to cause stress concentrations.

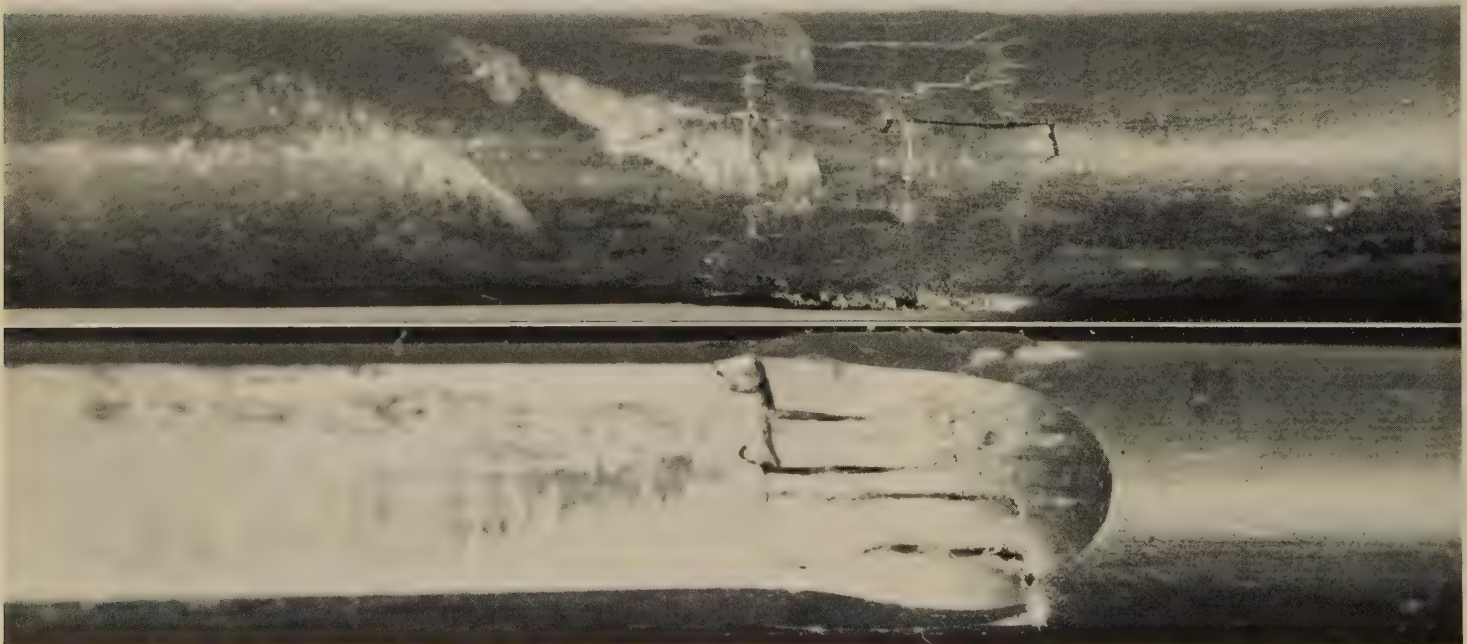
Photographs $5 \times$
4918 Two sides of a fractured $\frac{5}{16}$ -in.-diam 1070 steel torsion bar that had been quenched, and tempered to a hardness of Rockwell C 45. The bar fractured in a torsional fatigue test, cracking along both longitudinal and transverse shear planes. The test was halted before the fracture was complete. The fracture occurred at a machined flat, which fitted into the test-machine grip. Compare with the torsion-bar fracture shown in fractograph 4920, on the facing page.

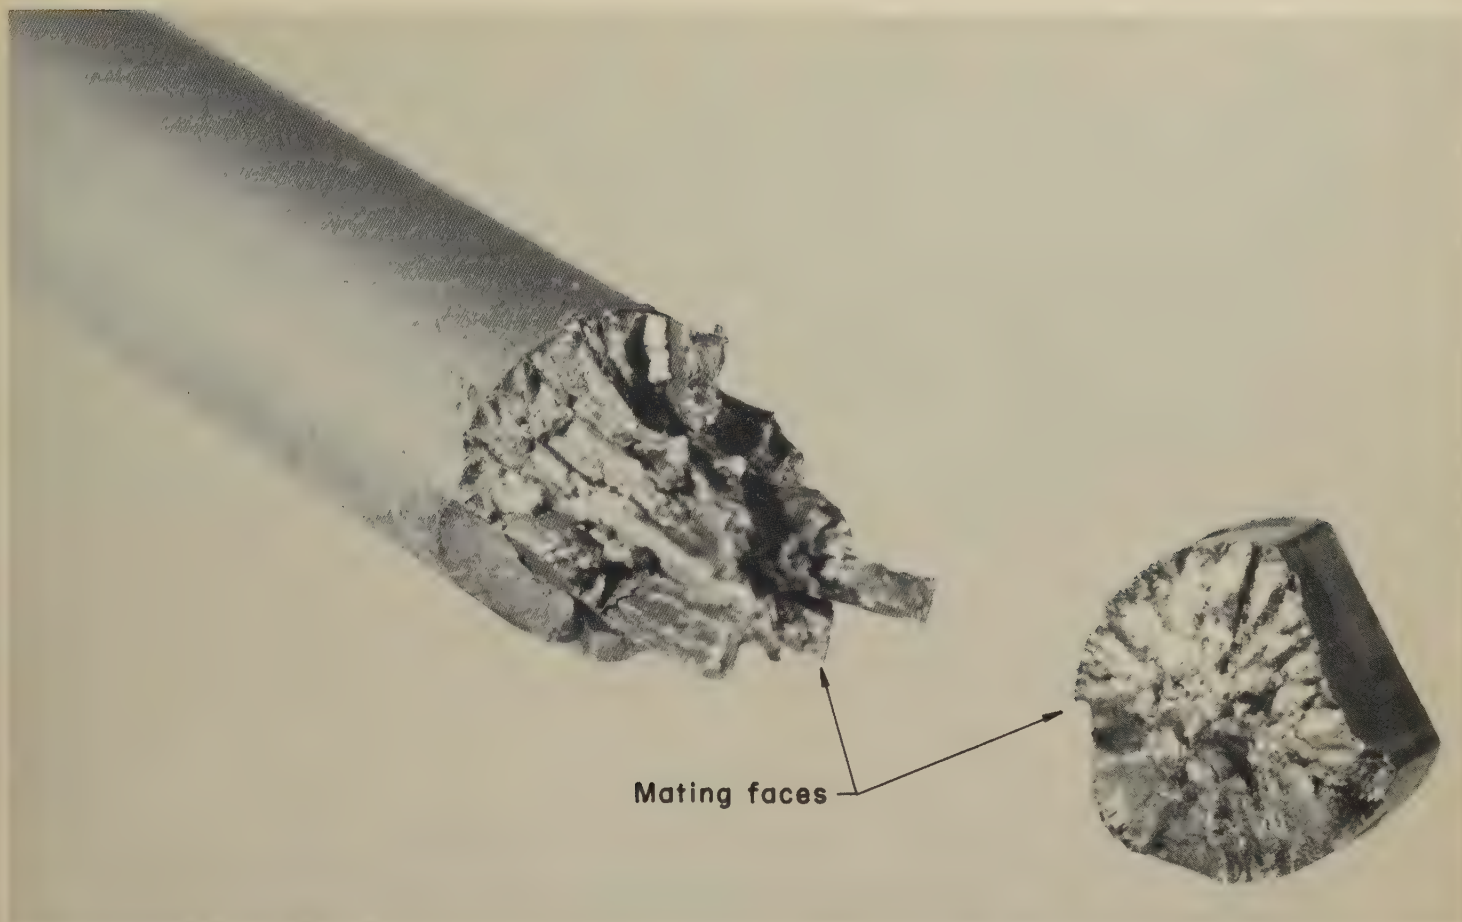
Light fractographs

4920 Torsional fatigue fracture in a $\frac{5}{16}$ -in.-diam torsion bar of 1070 steel that was quenched, and tempered to a hardness of Rockwell C 45. This fracture is similar to that in 4818 and 4819 (facing page) except that complete separation occurred here; the same pattern of fatigue cracks along longitudinal and transverse shear planes is evident.

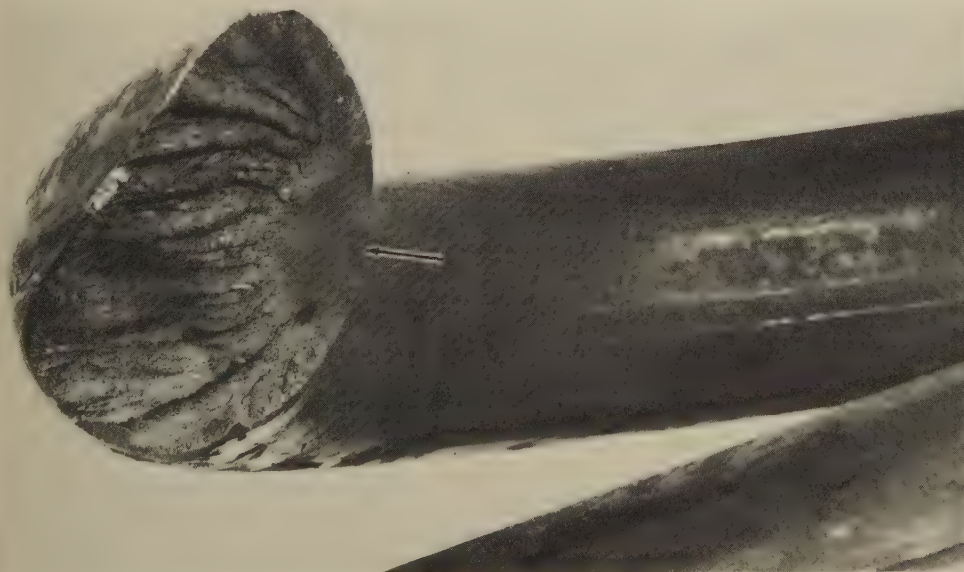
Light fractograph

4921 Surface of a fatigue fracture, which occurred after about one year of service, in a 1095 steel spring of a 250-ton shear. A fatigue zone is evident at the inner (right) edge of the fracture surface (at arrow). This is a normal location for a fatigue-crack origin in a coiled spring, and the fracture may be rated as typical. The fatigue crack penetrated a distance of approximately $\frac{1}{2}$ in. into the spring before final, fast fracture occurred. See also micrograph 4922, at right.

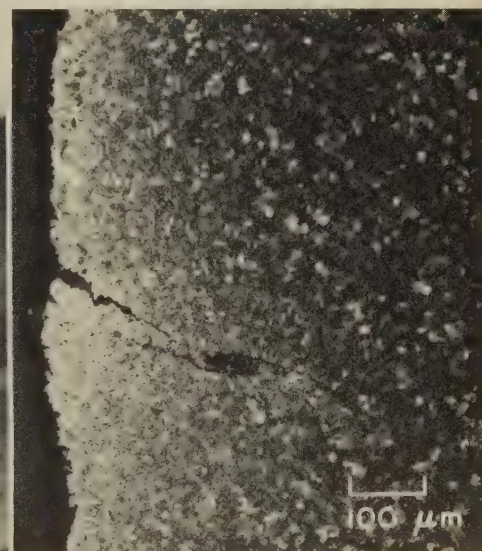
Micrograph (nital)

4922 Polished and etched section through the spring in 4921, taken adjacent to the fracture. Visible is a crack-like defect that probably nucleated the fatigue crack. Decarburization (white zone) around the defect indicates that the defect is a seam, which existed prior to service.

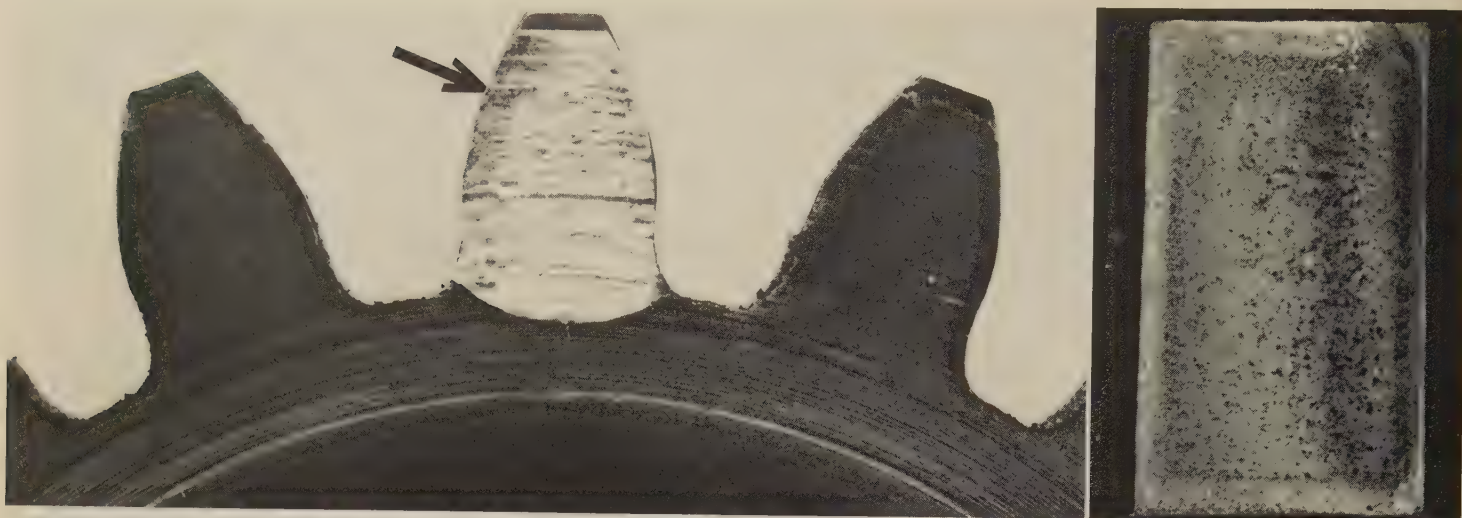
Photograph

4923, 4924 At left (4923) is a side view of a carburized gear of 4118 steel in which a tooth fractured by fatigue. (The tooth fragment was whitened to provide contrast with the remainder of the gear and was repositioned on the gear for this photograph.) The arrow indicates the point at which the major cantilever-bending load was exerted on the tooth, producing tensile stress in the root fillet below, where the fatigue crack originated. Fractograph 4924 (right) shows the fracture surface of the broken gear tooth, with a very fine texture at left edge (where the crack originated) and a rougher texture at right.

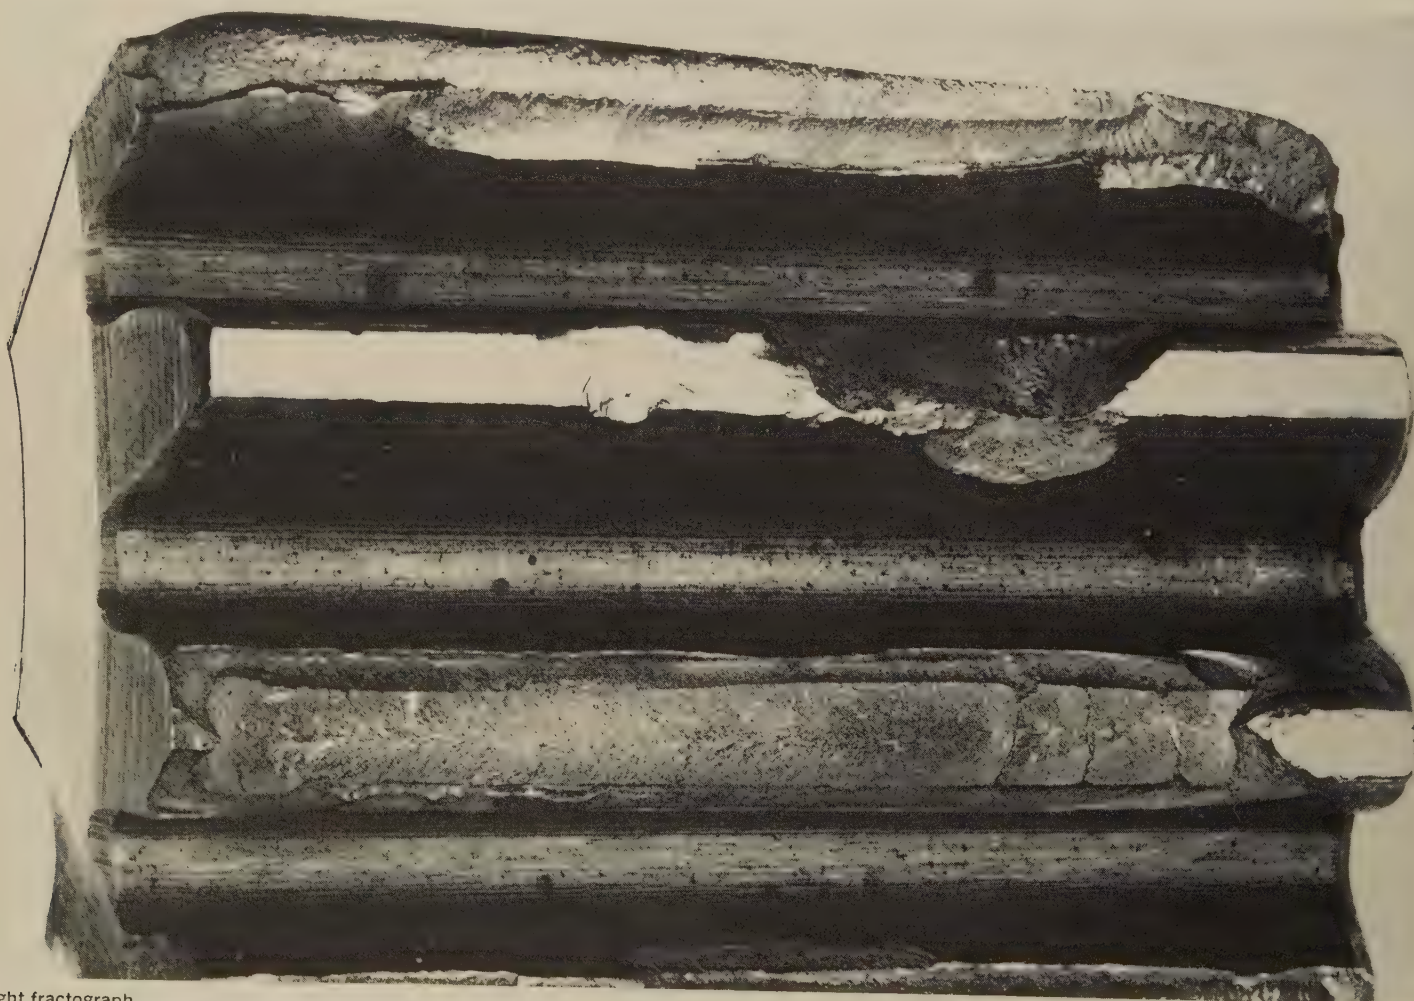
Light fractograph

4925 A planet gear of 4118 steel in which most of the tips of the teeth broke off after brief service. The gear was carburized and heat treated to a case hardness of about Rockwell C 60. The case extended, however, to an excessive depth, which created a high residual tensile stress at the interface between the case and the core. The additional stresses from service loading initiated cracks at this interface; ultimately, these cracks propagated, probably by fatigue, to the surfaces of teeth.

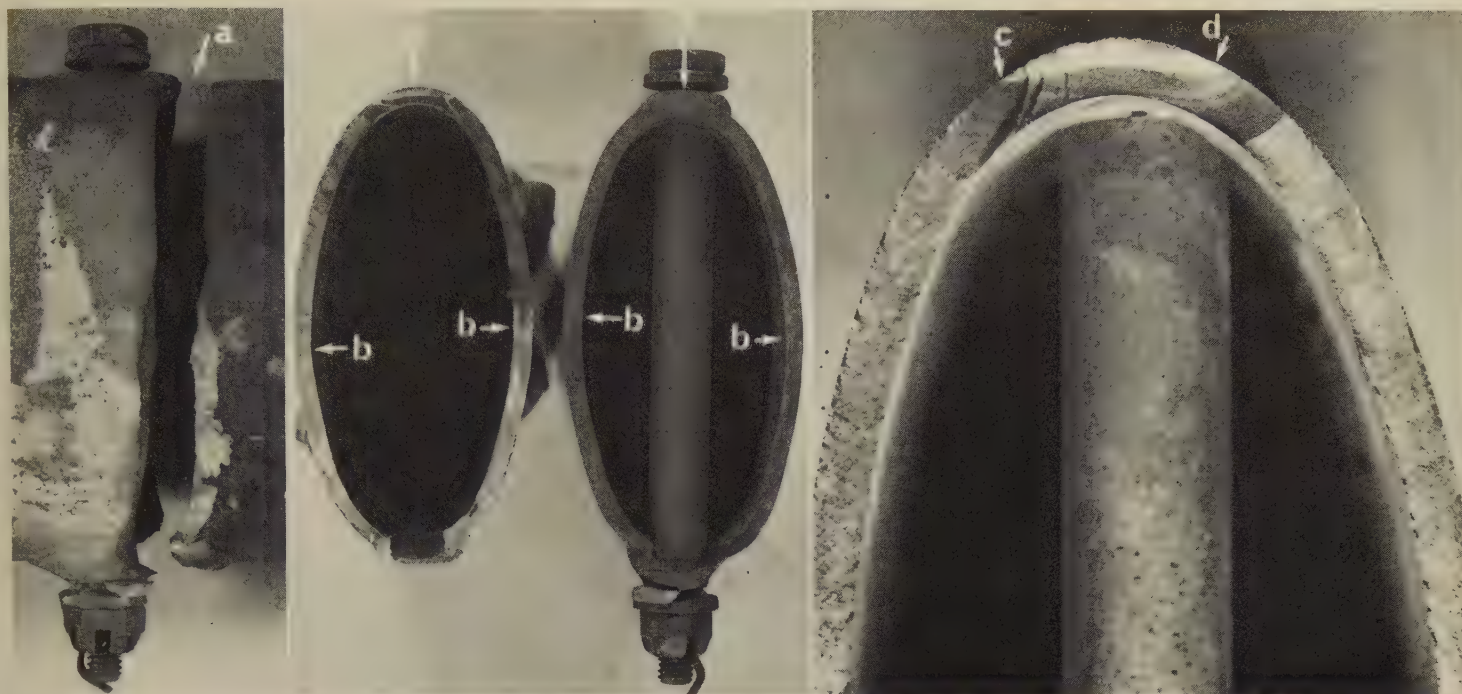
Photograph Actual size Light fractograph Actual size Light fractograph 5×
4926, 4927, 4928 At left (4926) is a view of a fatigue fracture in the lower cap of an aircraft wing-spar assembly. The cap was formed of 4130 steel elliptical tubing, with a 0.10-in.-thick wall, heat treated to a tensile strength of 1138 to 1344 MPa (165 to 195 ksi). A skin-attachment bolt, contained in a tube passing through and welded to the cap, was close to the fracture, which originated at "a" (top). At center (4927) is a view of the surfaces of the fracture in 4926; again, the fatigue-crack origin is at "a" (top). The points at which final, fast fracture began are marked "b". At right (4928) is a higher-magnification view of the top portion of the fracture surface at right in 4927, showing the area of initiation of the fatigue crack, which originated at a welding crack formed during attachment of the bolt tube prior to heat treatment. The region between "c" and "d" appears light because of rubbing by the mating surface before final, fast fracture occurred.

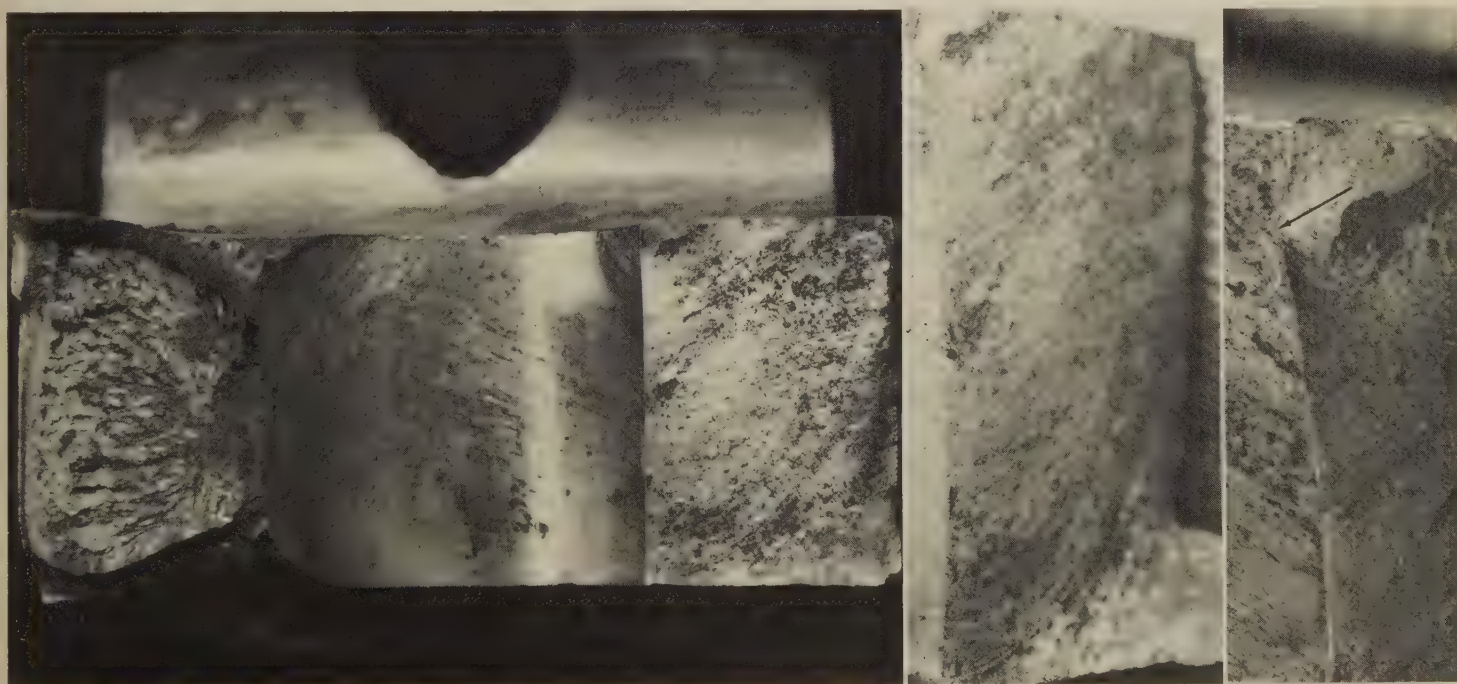
Light fractograph 2× Light fractograph 4× Light fractograph 10×
4929, 4930, 4931 Three views of a fracture in an aircraft lower wing-attachment fitting, which originated at a fatigue crack in an area of fretting and corrosion at a bolthole. The fitting was made of 4130 steel and heat treated to a tensile strength of about 1034 MPa (150 ksi). The fracture face at right in fractograph 4929 (left) was produced 95% by fatigue and contains a shear lip (bottom right); the fracture face at left in 4929 was produced by bending overload after the right side of the fitting had fractured. At center (fractograph 4930) is an oblique view of the fracture face at right in 4929, displaying the shear lip more clearly. At right (fractograph 4931) is a higher-magnification view of the area at upper left in 4930, showing the fatigue-crack origin (at arrow) and the fretting and corrosion in the bolthole (at left).

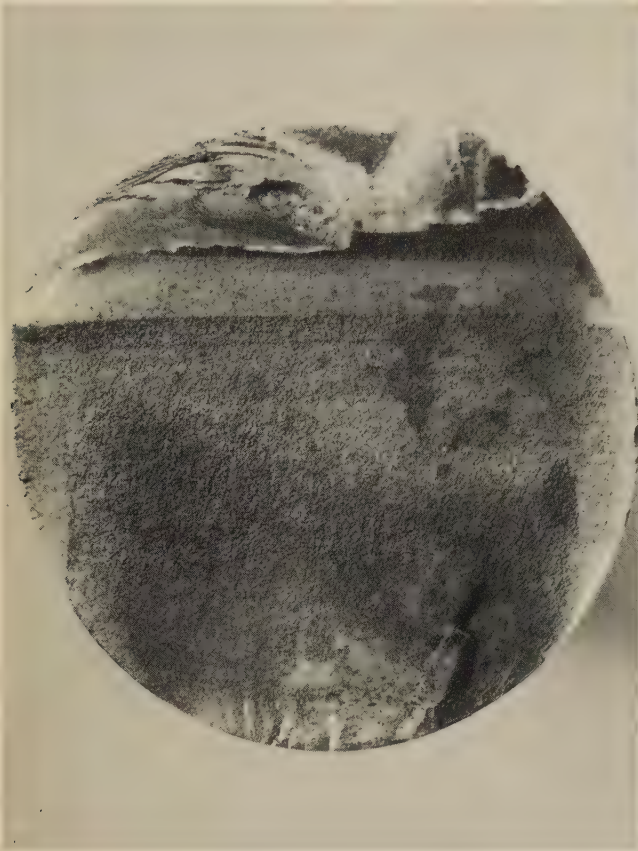
Light fractograph 2×
4932 Surface of a fatigue fracture in a stud of 4140 steel with hardness of Rockwell C 34 in the core and Rockwell C 45 at the surface. The crack originated at bottom in this view, in a well-rubbed fatigue zone, and penetrated nearly 90% of the cross section of the stud before final, fast fracture occurred.

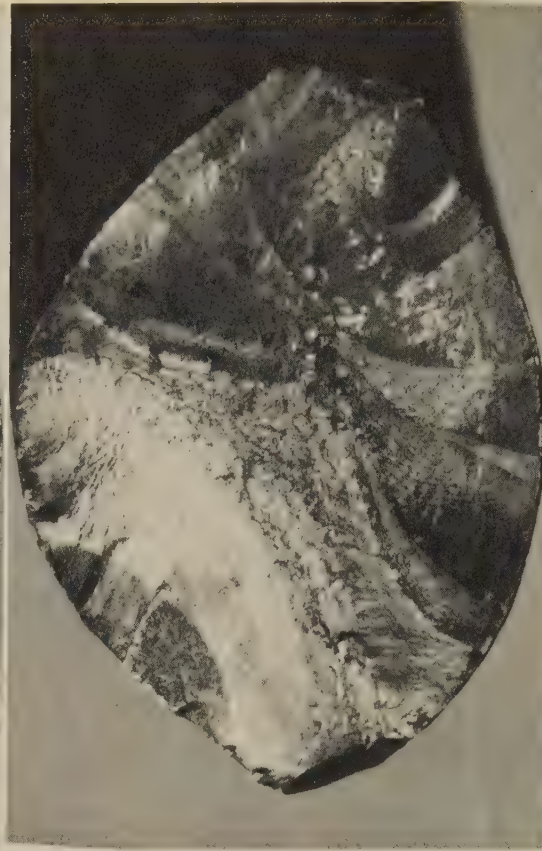
Light fractograph 5×
4933 Surface of a fatigue fracture in a suspension component of 4140 steel heat treated to a hardness of 273 Bhn. Two fatigue zones are evident, at lower left and at upper right; the remainder of the fracture surface is the zone of final, fast fracture.

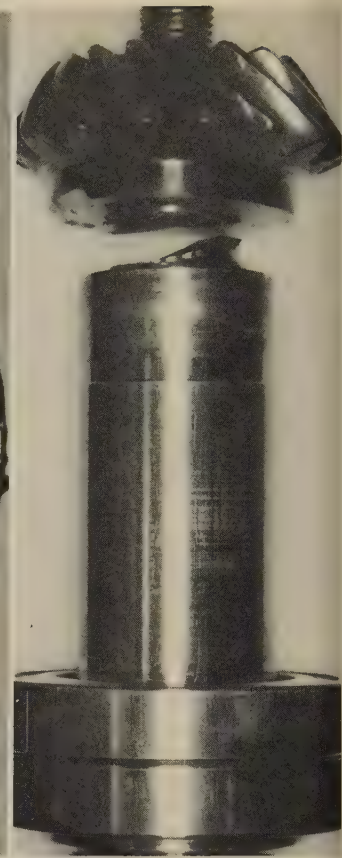
Photograph Actual size
4934 Fatigue fracture in a 4140 steel tail-rotor drive-pinion shaft of a helicopter, heat treated to a hardness of Rockwell C 35. See also 4935 through 4938.

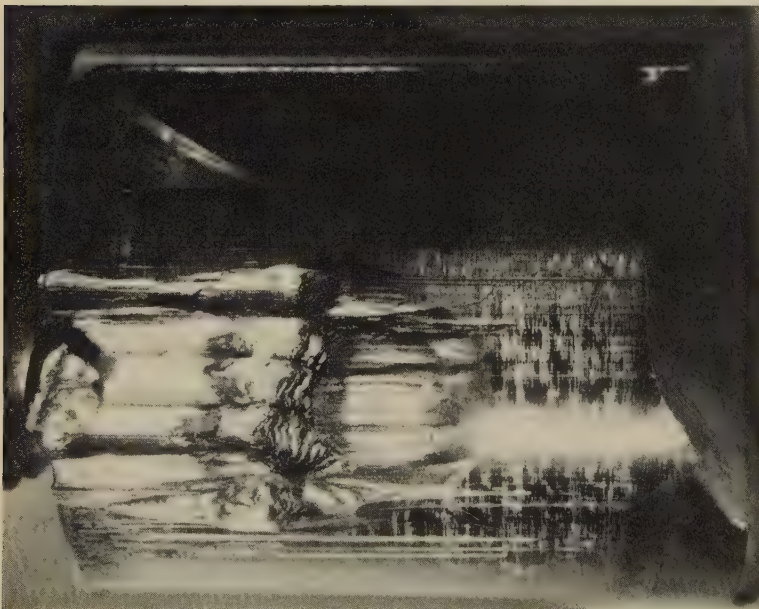
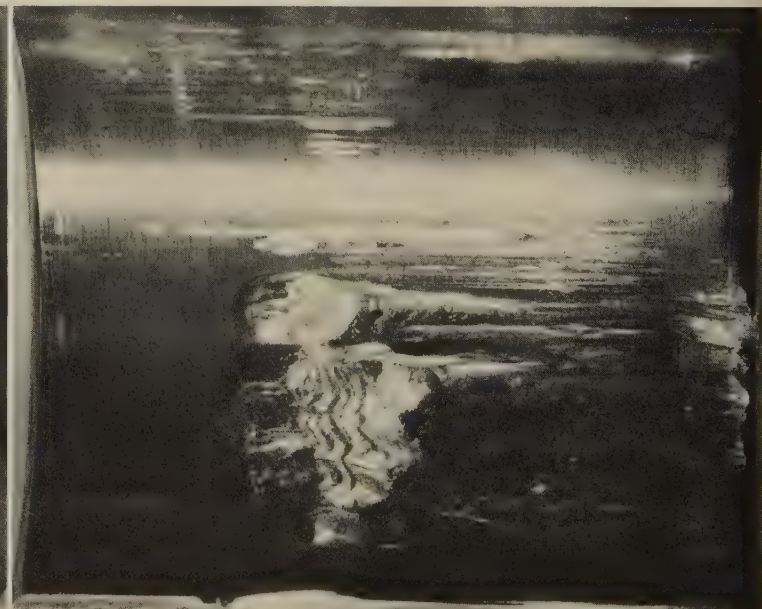
Photograph
4935, 4936

At left (4935) is a view of the threaded end of the fractured shaft in 4934, after removal of the pinion gear. At right (4936) is a view of the bore of the pinion gear. Both photographs display severe galling damage of the contacting surfaces, which resulted in the gear being frozen on the shaft; the gear was removed by cutting through it from both sides. The appearance of the gouge marks indicates that most of the galling damage was done in forcing the gear onto the shaft. Photograph 4935 (left) shows also a keyway and an oblique view of a fracture surface; the fracture originated at a location on the keyway edge that is not visible here.

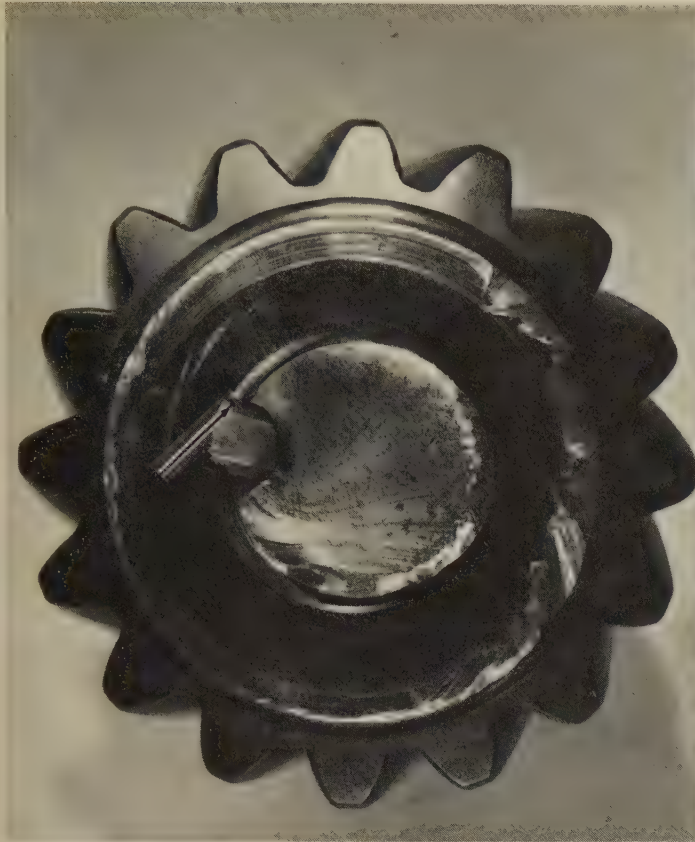
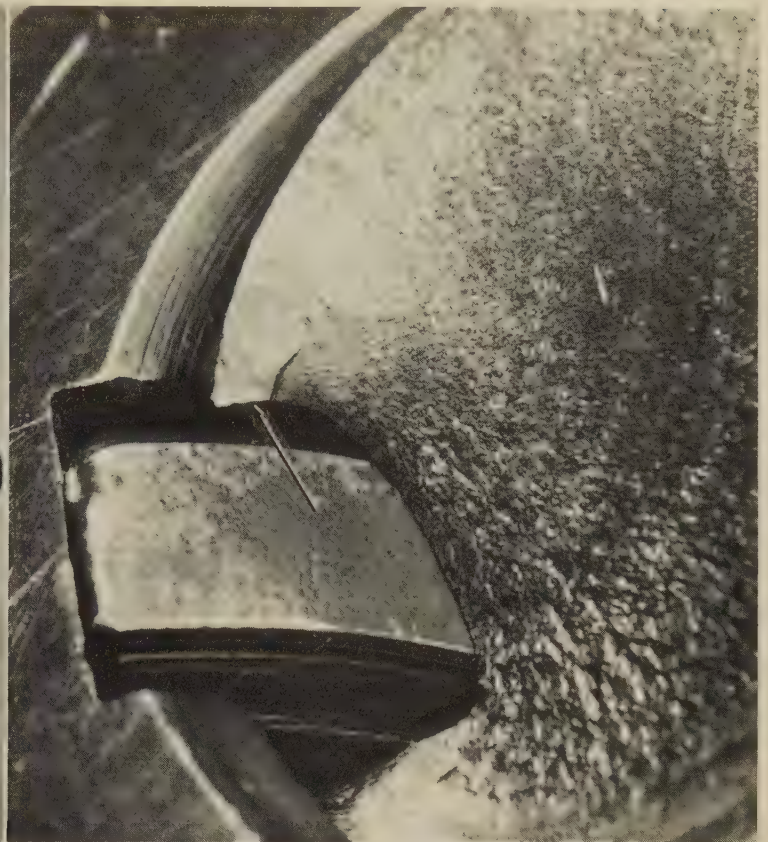
4937, 4938

Two views of a surface of the fatigue fracture in the tail-rotor drive-pinion shaft in 4934, taken with the key and the pinion gear in place. The fatigue-crack origin (arrows) is in the keyway, slightly to the right of the corner formed by the edge of the keyway and the outside surface of the shaft. Not visible here are deep tool marks and machining tears on the inside of the keyway, which were the sources of the stress concentrations responsible for initiation of the fatigue crack. The smooth fracture surface shown in these views is typical of those produced by high-cycle fatigue in combined bending and torsion.

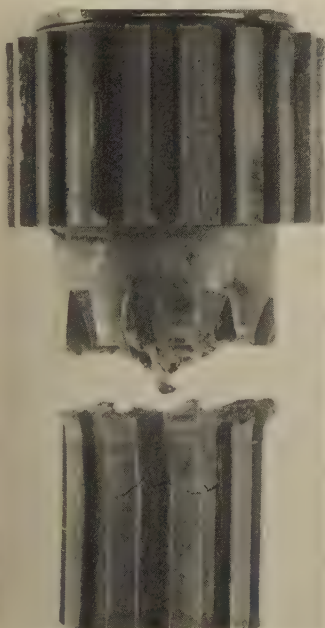
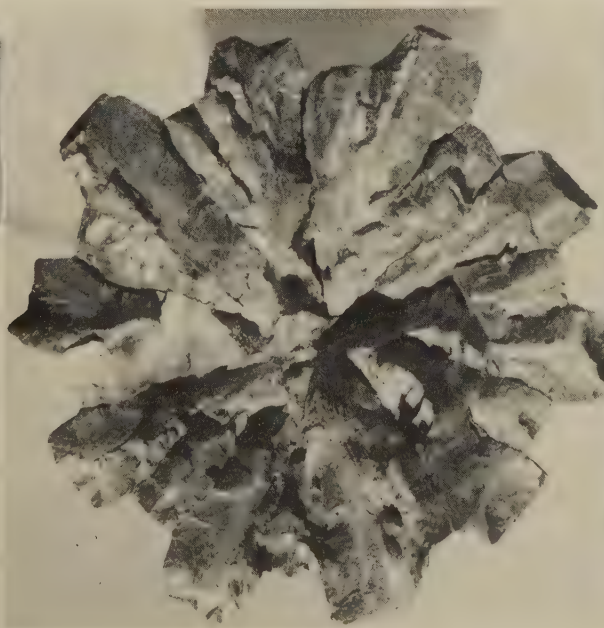
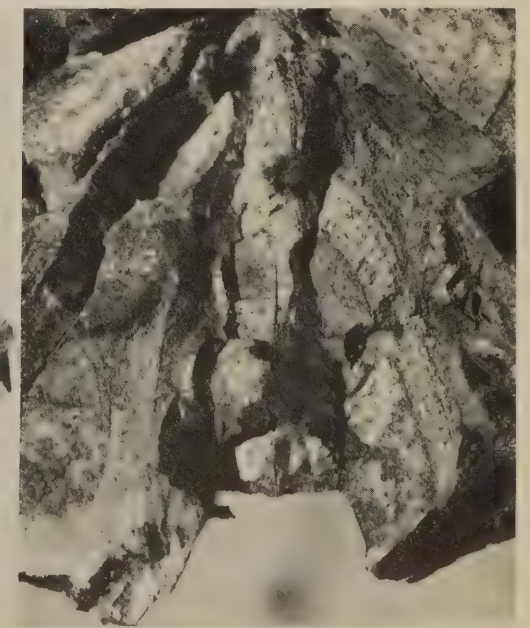
Photograph 4939 (at left) shows a fractured 4150 steel splined shaft heat treated to a hardness of Rockwell C 43. Note that there is a secondary transverse crack below the main fracture. At center (fractograph 4940) is a view of one surface of the fracture in 4939, showing a very complicated starlike pattern. Close examination of the many arms of the "star" reveals the presence of fatigue beach marks produced by crack fronts that propagated separately but simultaneously. Particularly evident are the beach marks on the arms at bottom, which are shown at higher magnification in fractograph 4941 (right). Sharp radii at the bases of the splines appear to have been the origins of the fatigue cracks.

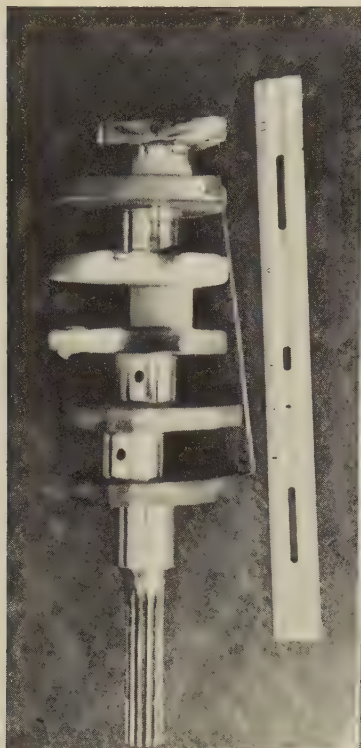
Photograph About $\frac{1}{4} \times$
4942 Outboard-motor crankshaft, forged of 4140 steel and heat treated to a hardness of Rockwell C 35 to 40, that fractured in service through a throw (at top). Chromium plating had been used to build up worn journals. See also 4943 to 4953.

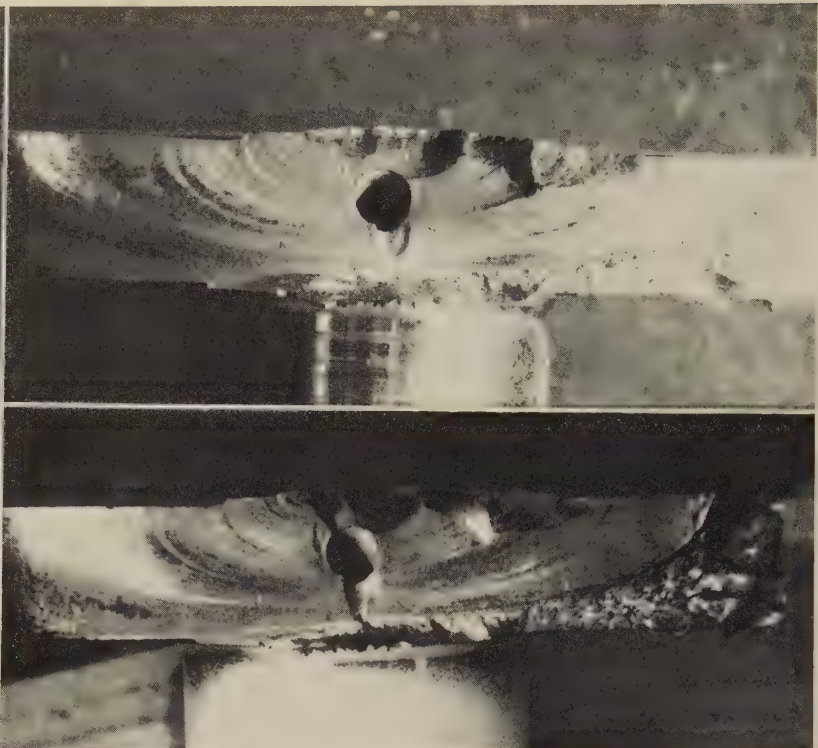
Light fractographs About $1.7 \times$ (4943); about $1.3 \times$ (4944)
4943 Fractograph 4943 (at top) is a view of the surface of the fracture in 4942, showing several small crack nuclei above the oil hole. Fatigue cracks from these nuclei merged to form a single crack front, which nearly penetrated the entire cross section of the throw before final, fast fracture occurred. Fractograph 4944 (at bottom) is another view of the surface of the fracture in 4942, photographed using illumination that reveals more of the details of the area of final, fast fracture than does 4943. The fatigue crack was initiated at a bottom fillet of the No. 2 main-bearing journal, which was chromium plated.

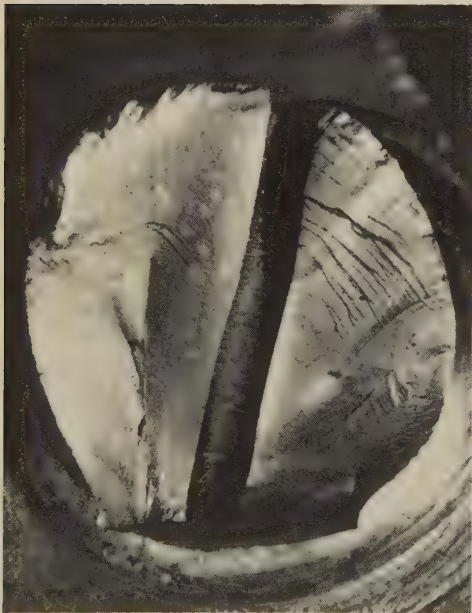
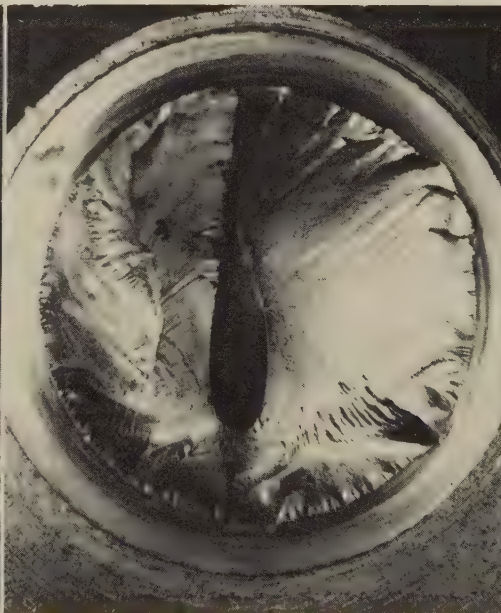
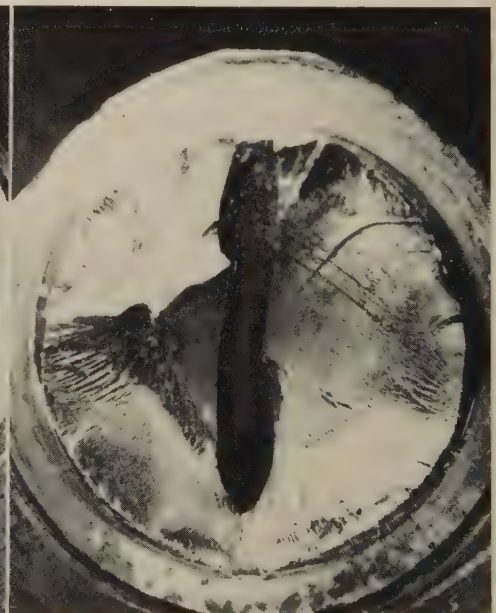
4945, 4946, 4947 Surfaces of three fatigue fractures in crankshafts the same as that in 4942; in each of these crankshafts, however, fracture progressed through a plated connecting-rod journal, rather than through a throw as in 4942. Each of these fractures originated at multiple nuclei along a fillet. Fatigue cracks began at these nuclei and then joined to form a single crack front along a portion of the journal periphery. Final separation was by fast fracture. In the fracture at left (4945), there are three or four crack nuclei at the right edge; the fatigue-crack front penetrated past the oil hole before final, fast fracture occurred. In the fractures at center (4946) and right (4947), fatigue cracks formed at many nuclei at the bottom edge, and the fatigue-crack front followed the oil hole toward the opposite edge. In 4947, a second crack front, independent of the main front, advanced from upper left.

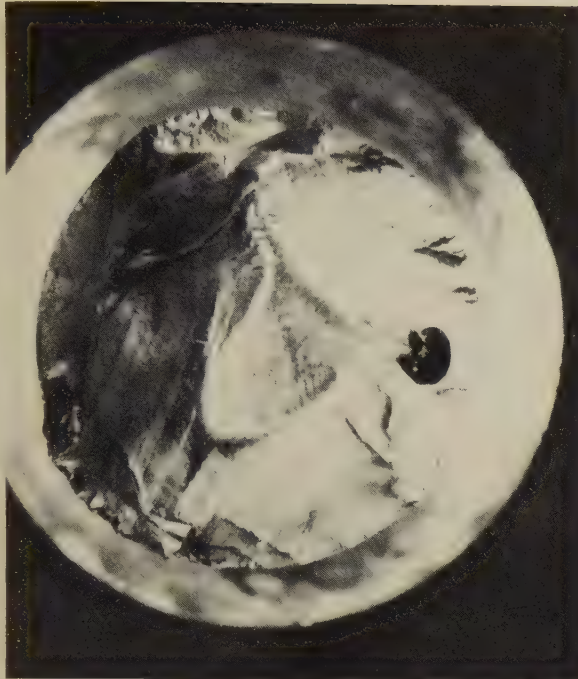
4948 Surface of a fatigue fracture through a chromium-plated connecting-rod journal in a crankshaft the same as those in 4942 to 4947 (opposite page), showing many brittle cracks, which originated in the chromium plating and converged to create four large, deeply penetrating fatigue cracks having very different facet angles.

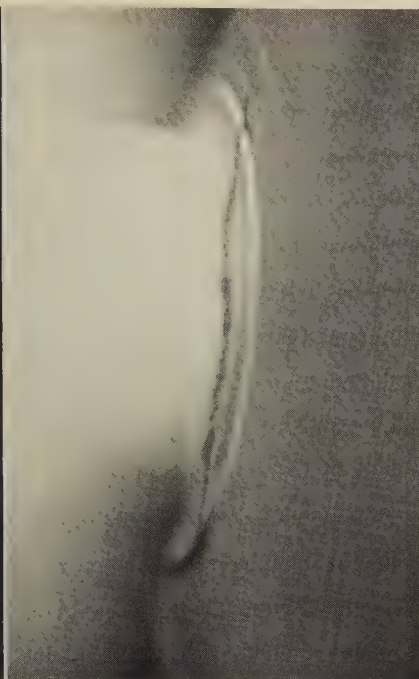
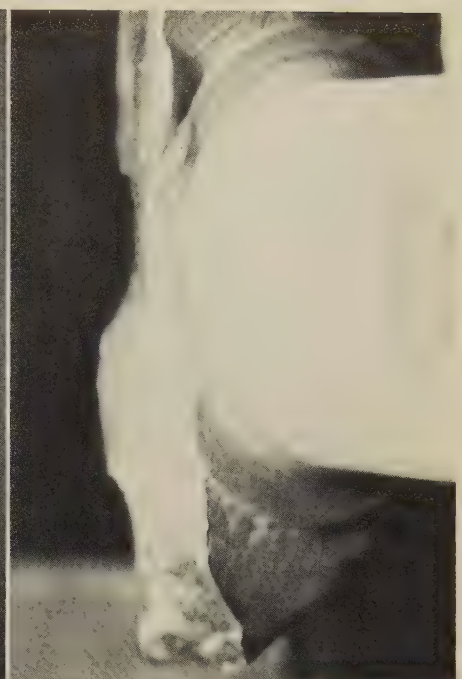
4949, 4950 At left (4949) is a view of a fillet of a chromium-plated connecting-rod journal in a crankshaft the same as those in 4942 to 4948, showing a crack revealed by magnetic-particle inspection. This crack is typical of those that grew to form the fractures shown on this page and on the facing page. (A similar secondary crack is visible at right in 4944.) Photograph 4950 (right) shows such secondary cracks in a fillet, immediately adjacent to a fracture in a throw of a companion crankshaft; see also 4951 and 4952.

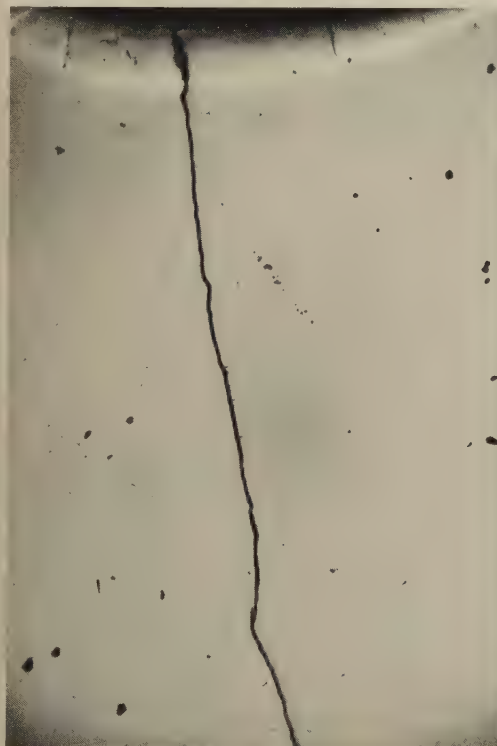
4951 Longitudinal section taken, at mid-height, through the fillet in 4950. Note the cracks in the chromium plating at top, one of which extends 0.185 in. into the base metal. Hardness of plating here and in 4952 and 4953 was Rockwell C 60 to 70.

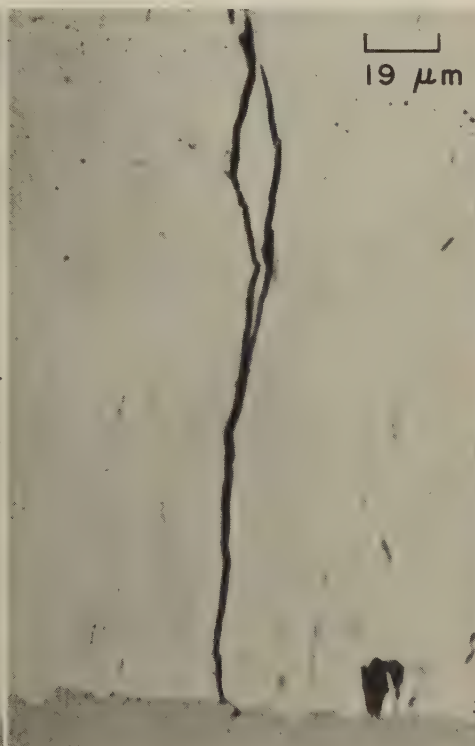
4952 Higher-magnification view of the first crack to the right of the deep crack in the chromium plating in 4951. Note that this crack had just begun to penetrate the base metal (at bottom).

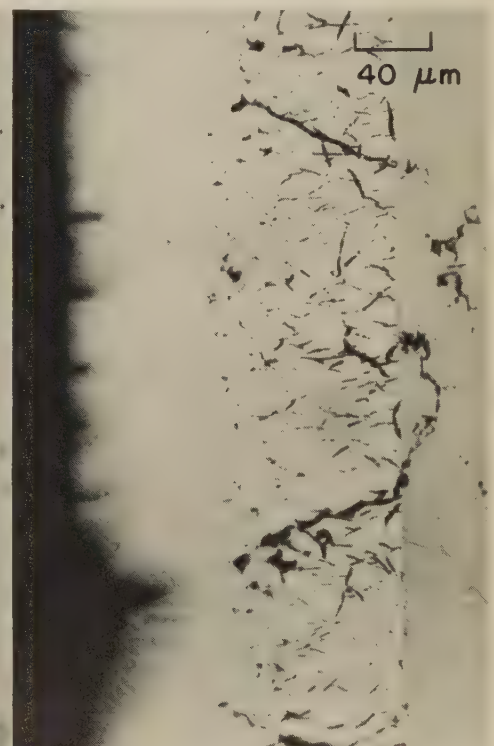
4953 Section through a chromium-plated journal typical of those in the crankshafts on these facing pages, showing cracks and considerable porosity, both of which contributed to fracture.
